REPORT OF THE
NATIONAL DAM SAFETY PROGRAM

PHASE I INSPECTION REPORT

⑥
National Dam Safety Program. Loch
Raven Dam (MD-0002), Gunpowder River
Basin, Gunpowder Falls, Baltimore County,
Maryland. Phase I Inspection Report.

PHASE I INSPECTION REPORT
NATIONAL DAM SAFETY PROGRAM
LOCH RAVEN DAM MD 0002

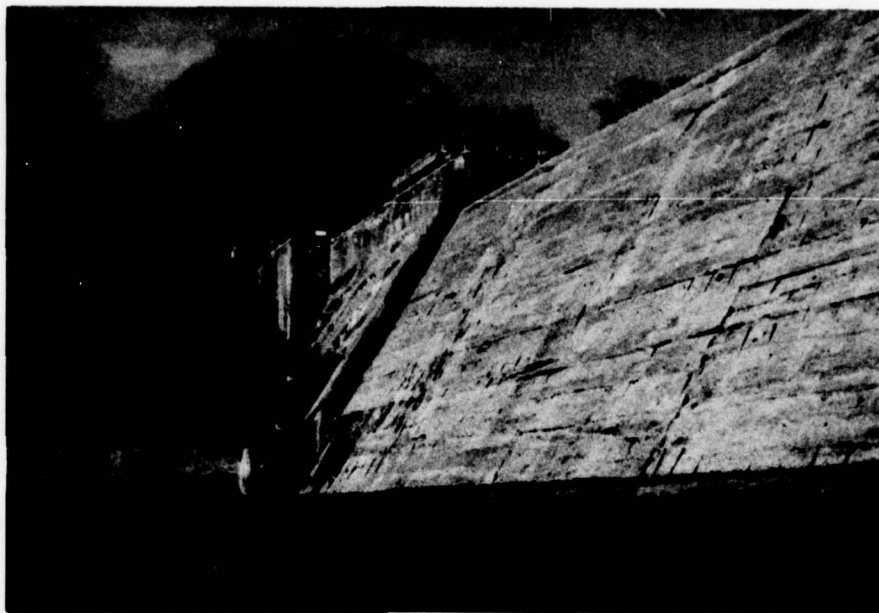
(7) Seepage along a horizontal construction joint was observed on the overflow section near the right side and on the non-overflow section on the upstream side of the left abutment above the pool elevation. (See photographs)

Seepage on Right Side Downstream Face of Spillway
